Project NY 450 004.4
Technical Note N-217
11 April 1955

CATHODIC PROTECTION STUDIES, November 1953 to
November 1954

U. S. Naval Civil Engineering Research and Evaluation Laboratory
Port Hueneme, California

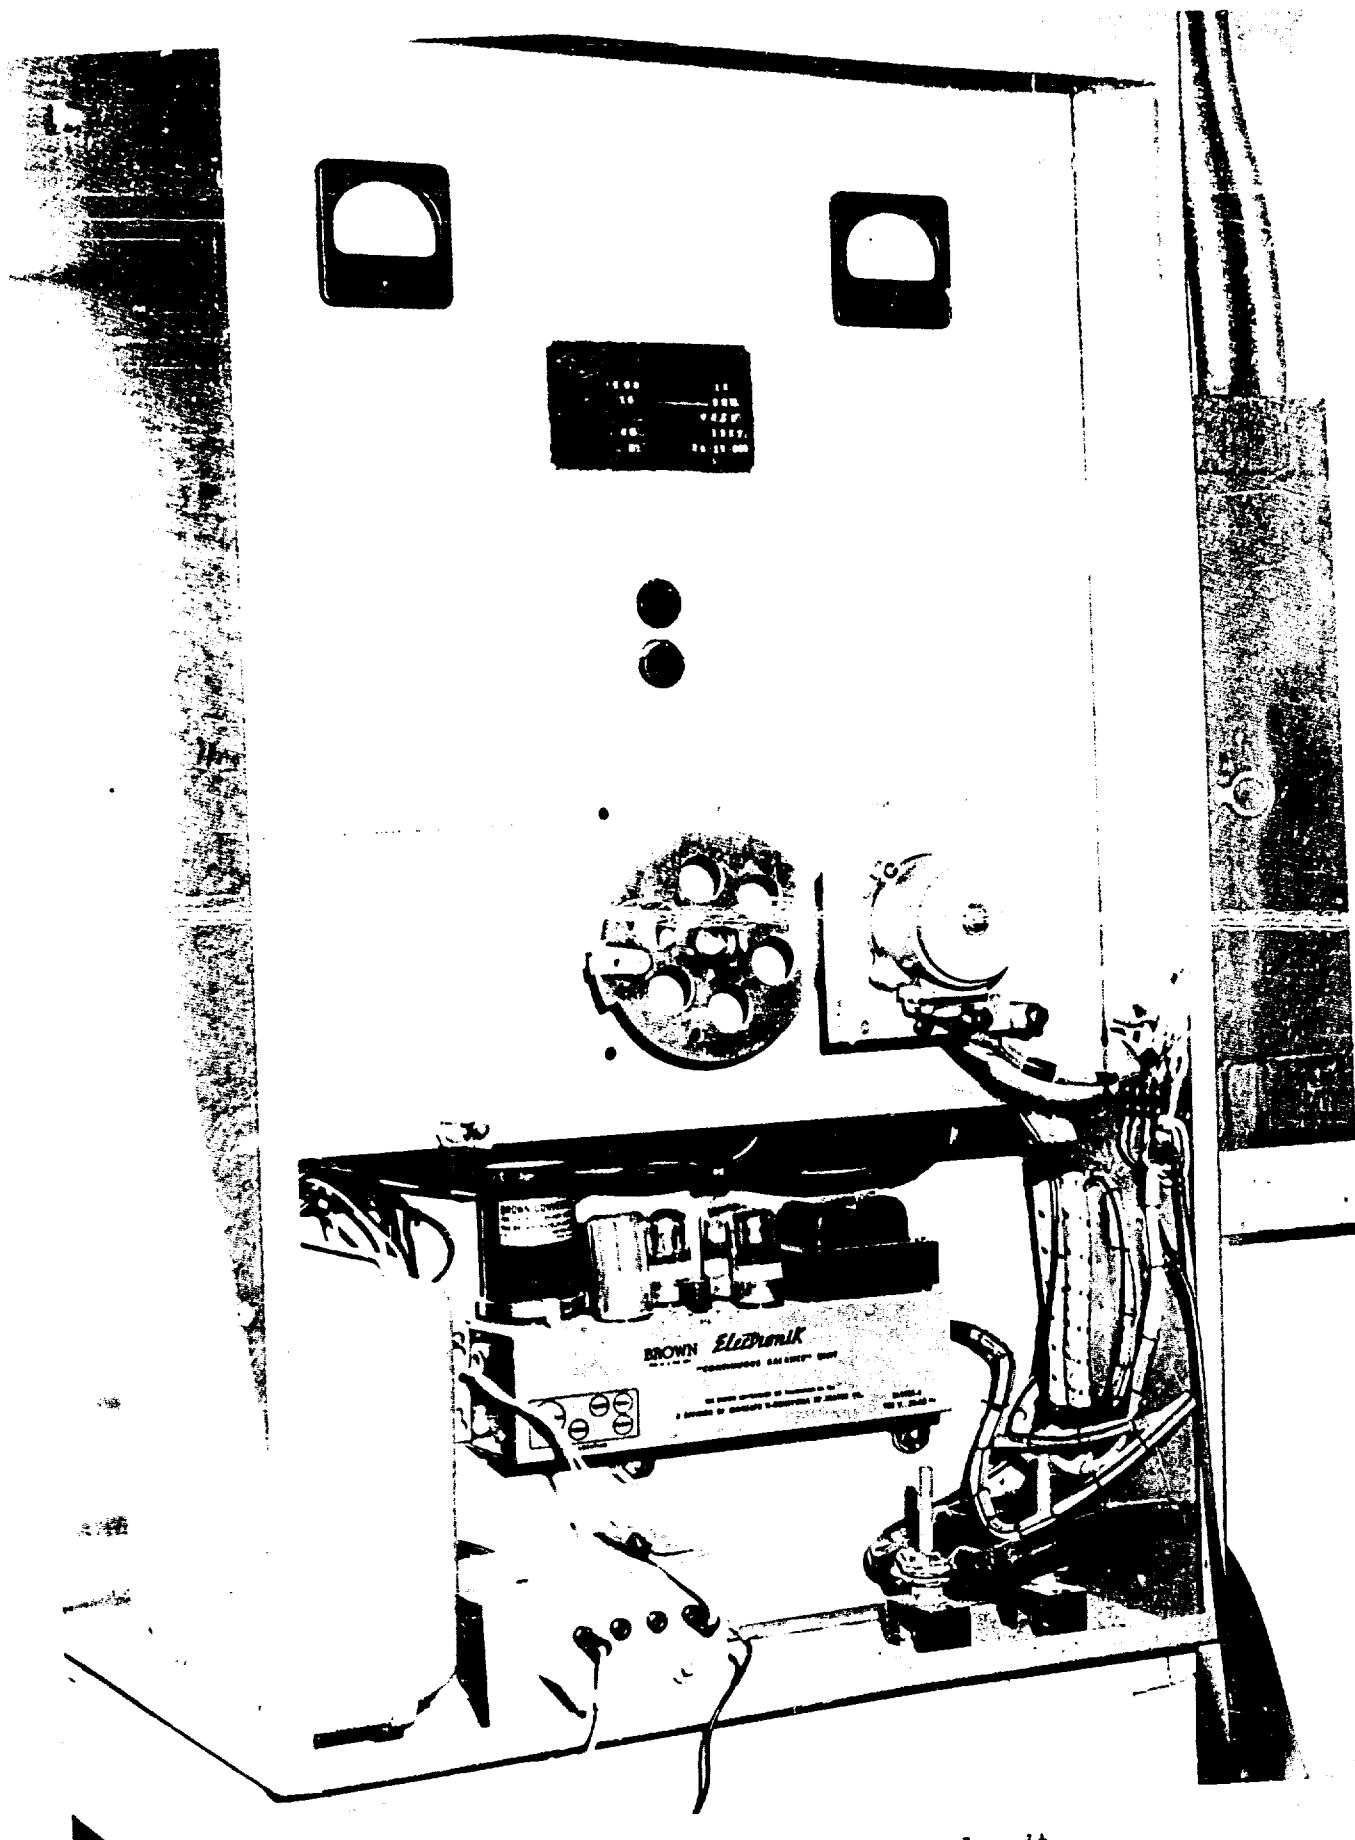
The amplifier and servo system as shown in Figure 17 have proven to be a compact, efficient unit and have required no maintenance in six months of operation. Initial installation of an electronic system rather than a complete magnetic amplifier type system, which would have inherently longer life, was made primarily for economic reasons. There are no complete magnetic amplifier-type systems commercially available, and the development of a unit would have to be made at considerable expense. The electronic equipment was installed at a cost of approximately \$200.00, with negligible modification of the power supply equipment. The limitations of the available signal power (order of 10^{-9} watts) is within the range of the input characteristics of electronic amplifiers. Magnetic amplifiers capable of operating at such a low signal power are still in the development stage.

Figure 17. Automatic current control unit mounted on rectifier panel.

The control system operates by regulating the rectifier current output for a specified value of hull potential as measured with a reference half cell. The signal to the amplifier is determined by the measuring circuit consisting of the half cell located in the water, a reference voltage circuit as shown in Figure 18, and a ground lead from the protected surface. The reference voltage is set at the desired level (850 millivolts for a Cu/CuSO_4 cell), and any error voltage between the reference and the measured half cell voltage due to hull polarization produces a signal which is amplified, causing the servo motor to rotate the rectifier variac so that the CP current is altered sufficiently to reduce the error voltage to zero. AC pickup by the half cell is minimized by the resistance capacitance filter as shown. The inherent slow response of polarization with current change (up to 15 minutes, depending upon the magnitude of the change) necessitates the use of stops on the servo control to limit the maximum current to a safe value. The amount of control would vary depending upon the installation and would determine what current limit would be necessary. In the installation described, a positive mechanical stop is employed which limits the servo drive pinion to one revolution allowing a current range of 30% of the total current. The control mechanism is set with the current adjusted to the approximate correct value midpoint between the stops, allowing sufficient current control for minor changes in the system. Some difficulty has been experienced in setting and maintaining the reference voltage when the system is considerably out of balance. A new reference voltage circuit with possible inclusion of a standardization feature is planned.
